PIPELINE CO. PIPE RUPTURE & PETROLEUM SPILL

WHEN THIRD PARTIES CAUSE ACCIDENTS ON RIGHTS OF WAY

BY GARY L. GLANCZ

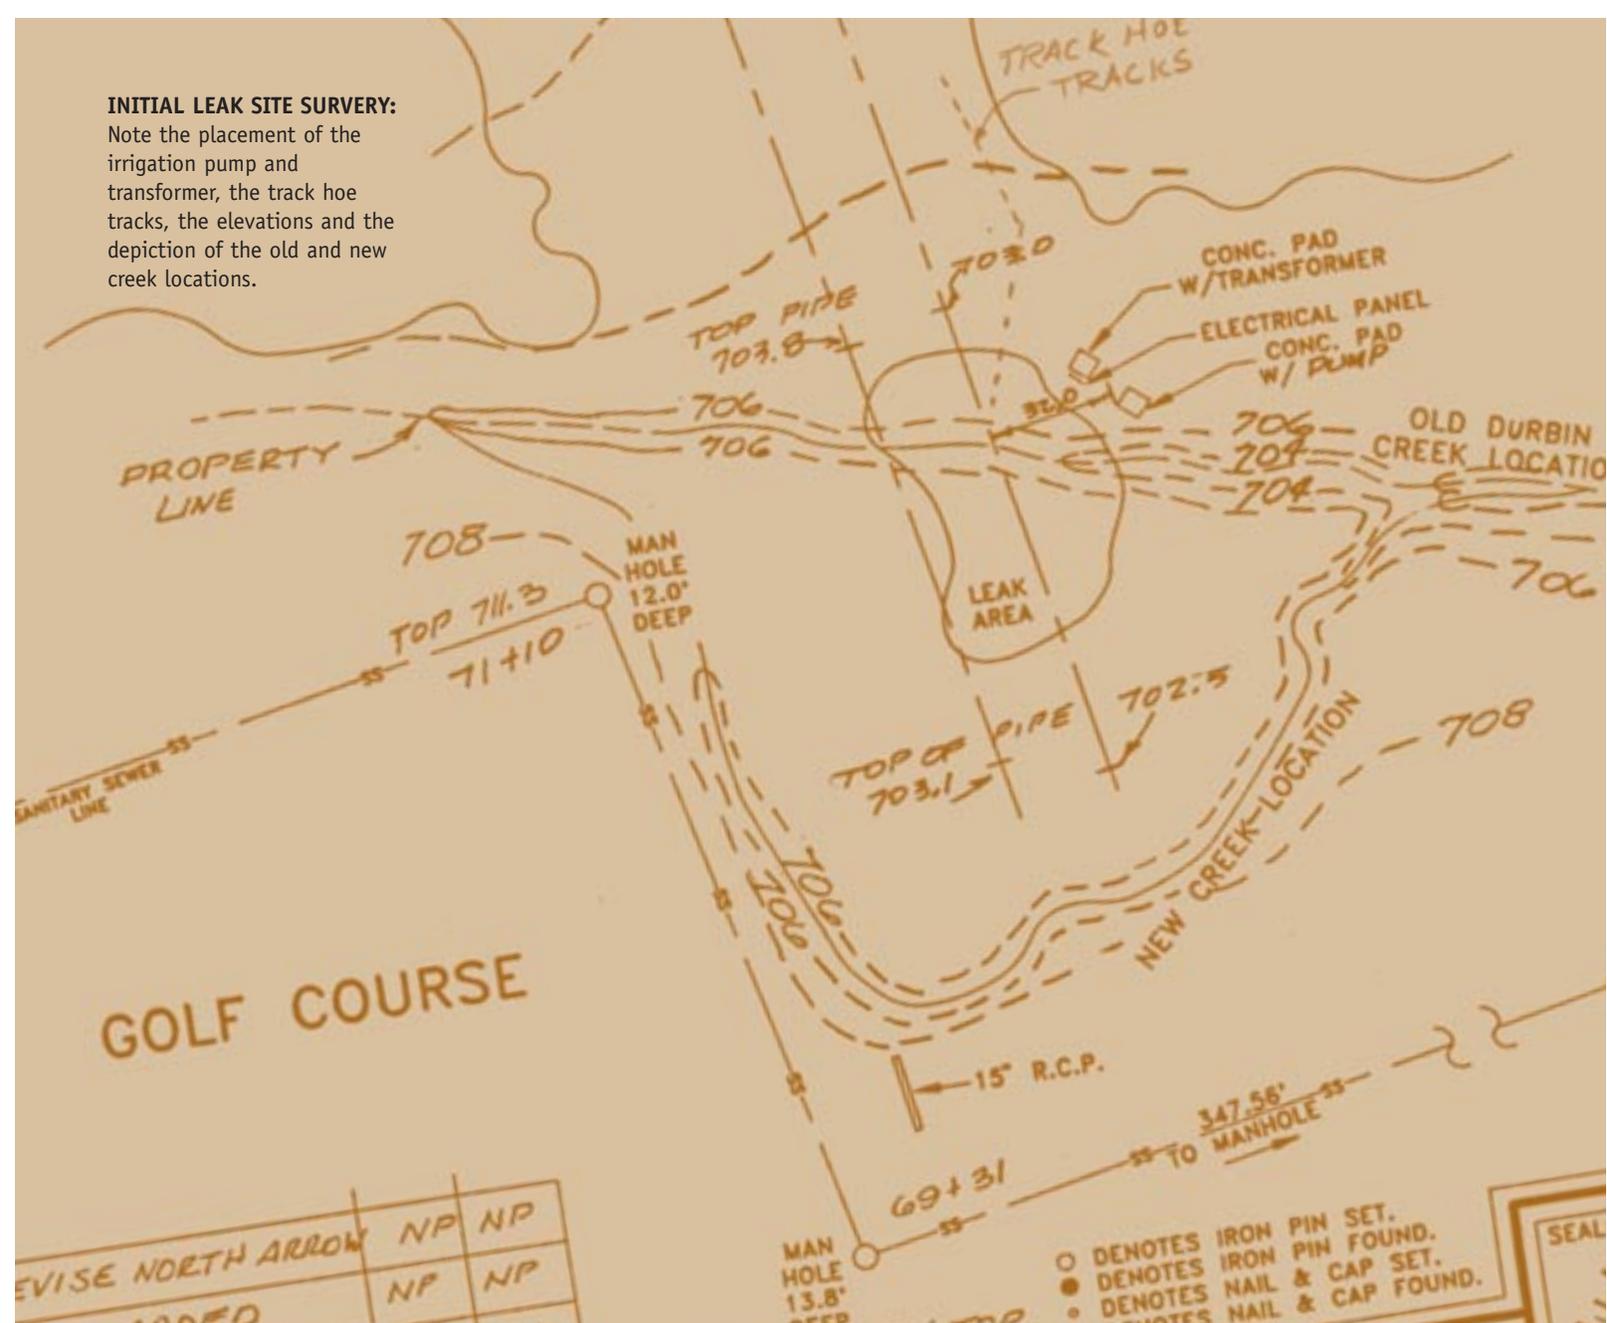
INITIAL LEAK SITE SURVEY:

Note the placement of the irrigation pump and transformer, the track hoe tracks, the elevations and the depiction of the old and new creek locations.

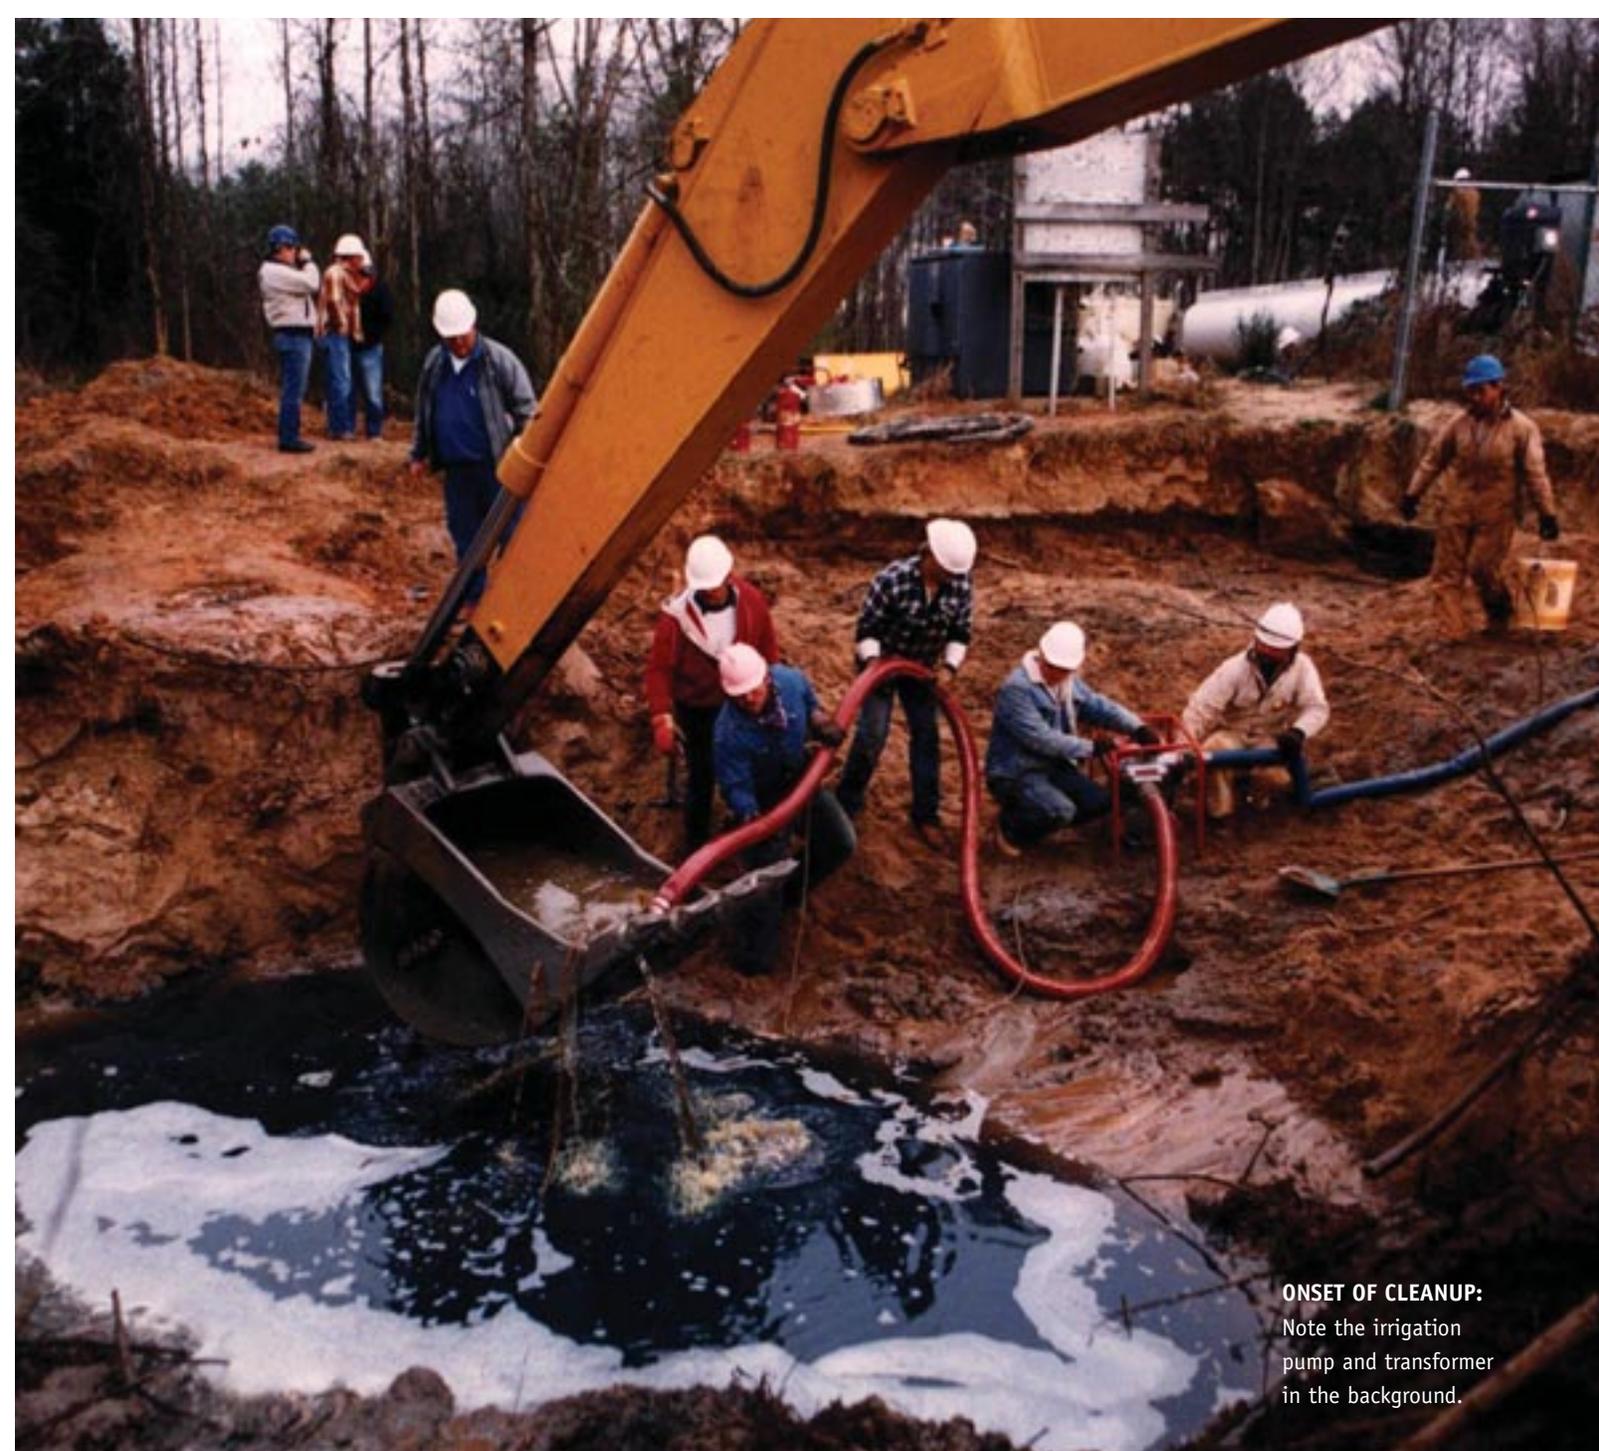
ONSET OF CLEANUP:
Note the irrigation
pump and transformer
in the background.

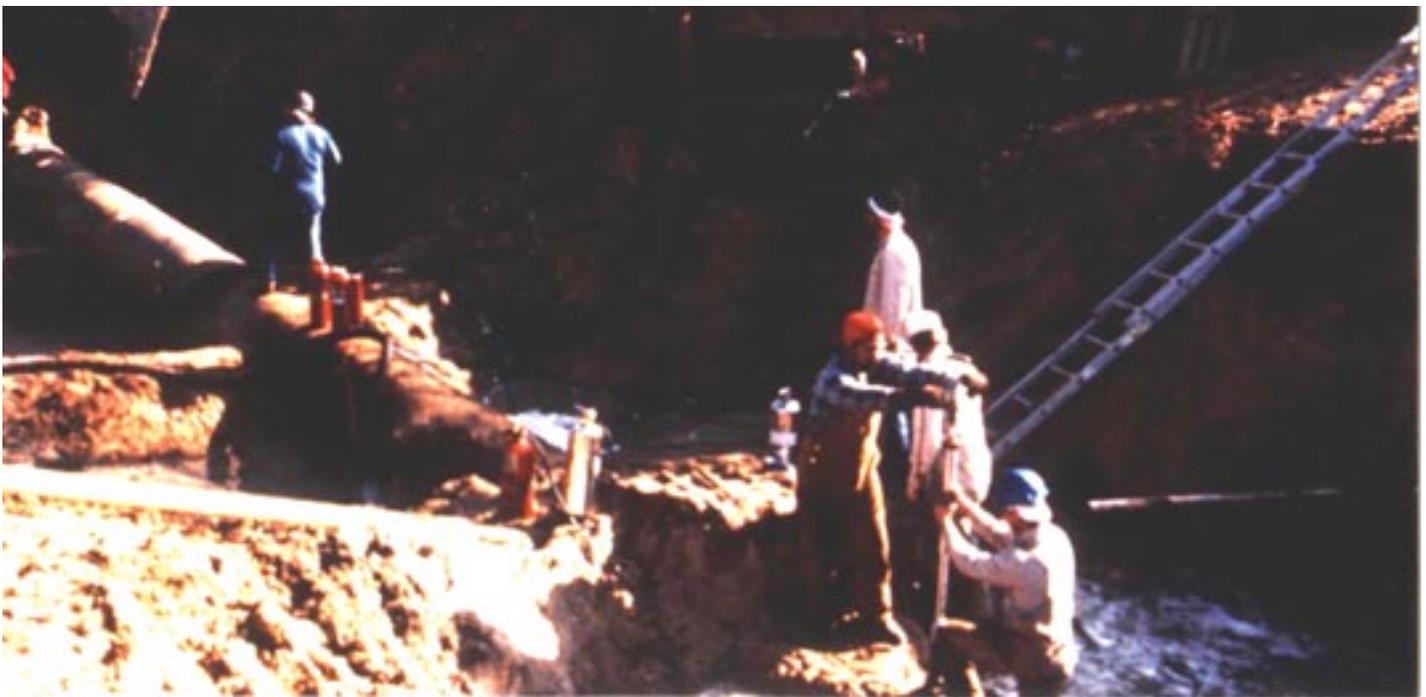
PIPELINE REPAIR: Note the placement of the track hoe in the background next to the irrigation pump. This is the exact placement of the Komatsu track hoe in the tracks we discovered. This photo was taken of another manufacturer of track hoe equipment with similar dimensions, and the piece of equipment appearing in the photo was able to swivel toward the pipeline and drag its bucket across the top of the pipeline as depicted. We were unable to photograph an exact depiction for fear we would create additional damage to the pipe or destroy existing evidence of damage.
