Valueless Property

How a Remainder Converts to a Remnant

BY RICHARD E. WELCH, SRPA, SRA, R/W-AC

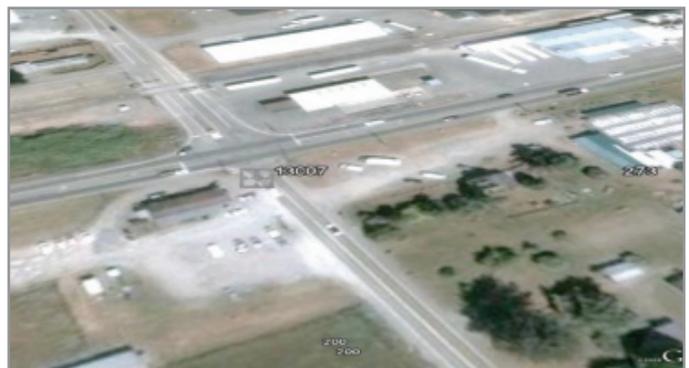
Satellite imaging shows the restaurant to the left (example #1) and the residence to the right (example #2). State Route 20 travels east/west and Avon Road travels north/south.

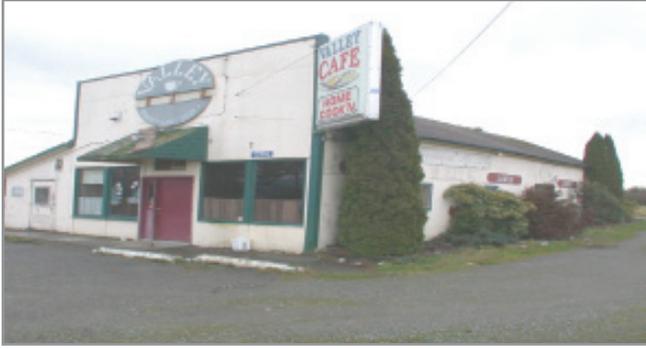
On the northern lot sits the restaurant, septic system with drain field and small parking area.

This example is the result of a partial acquisition by the Washington State Department of Transportation (WDOT). The larger parcel consisted of two lots located at the southwest corner of State Route 20 and Avon Allen Road in Mount Vernon, Washington. The two lots are dissected by Railroad Street and have frontage on both SR 20 and Avon Allen Road.

The WDOT acquired the entire northern lot of 14,032 sq. ft. and a portion of the southern lot measuring 726 square feet. In essence, the bulk of usable land was acquired, including the restaurant, septic system, drain field, and a portion of the adjacent parking lot. All that remained was a section of the southern parking lot, which had restricted access on one side (along SR 20) and only 50 feet of street access on the other side (along Avon Allen Road).

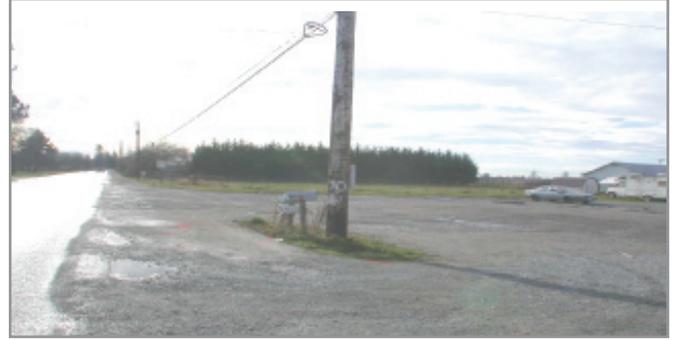
The southern lot served as the main parking lot for the adjacent restaurant.

It was estimated that the building would require at least 2,000 sq. ft. and 28 parking spaces per code. That would leave about 7,700 sq. ft. of land remaining, and the county planners were doubtful that the septic system and drain field could be accommodated in that small space. Therefore, to achieve the original commercial usage, additional land would need to be acquired. Unfortunately, the surrounding land was zoned for agricultural use, not commercial use. As a result, acquiring additional commercial land was not feasible.

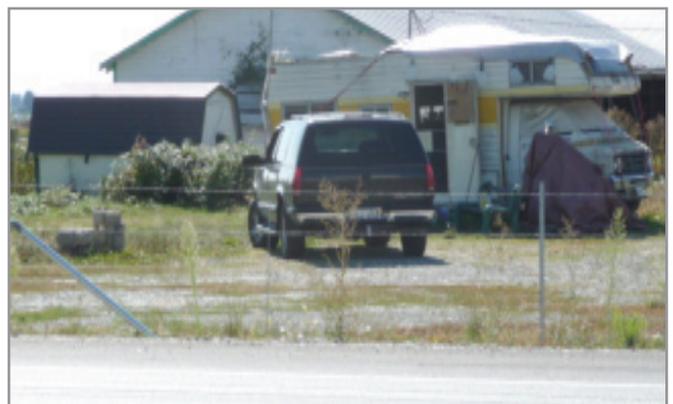
In this case, the remnant became nothing more than an empty lot that ended up being used for parking!

In addition, there were sign and access restrictions, and limited visibility for the potential commercial use due to setback requirements. The remainder appeared to be a misplaced commercial zoned parcel adjacent to agricultural land. The only possible use would be as assemblage to adjacent agricultural land. The feasibility study concluded that the remaining land could not be used for commercial purposes. With no highest and best use for the remaining property, the result was a remnant.

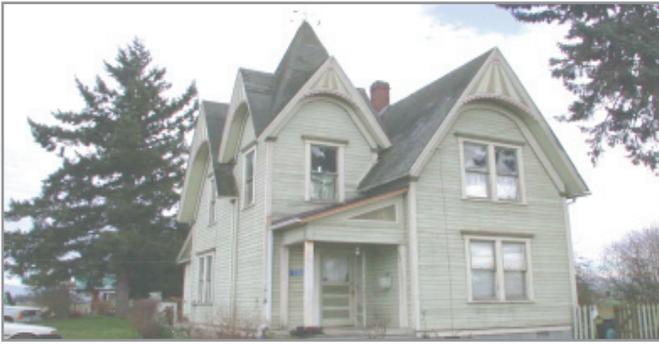
Front of the residence before the taking.

The historic residence, which was constructed in 1901, was comprised of 1,595 sq. ft. of livable area within a two-story residence. The residence contained about $\frac{3}{4}$ of an acre, or 32,670 sq. ft., and the commercial retail portion was on $2\frac{3}{4}$ acres zoned for produce, parking, retail buildings and seasonal roadside stands. For simplification, we will address just the residential portion to demonstrate why this remainder did not revert to a remnant.

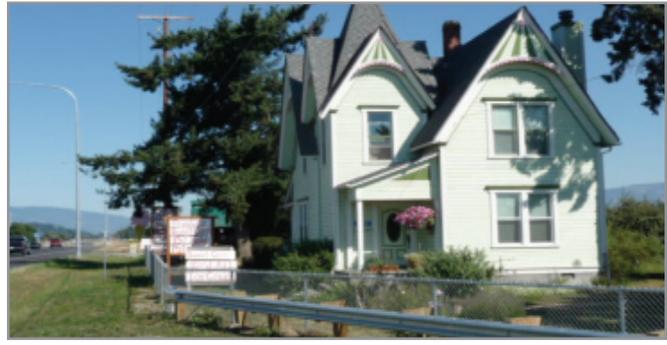
Front of the residence after the taking.

The WDOT acquired about 14,670 sq. ft. of the residential lot. This taking included approximately 90 feet

of frontage along SR 20 from Avon Allen Road plus a strip along Avon Allen Road of about 25 feet. The septic system would require reconstruction.

It was determined that the residence in the after condition would not be critically impacted. The first floor area of 1,000 sq. ft. left approximately 17,000 sq. ft. for the septic system and yard area. This is what typically happens in a partial taking when the existing improvements remain functional in the after condition with a smaller lot size and usable improvements.
